# NOTICE OF PROPOSED DEVELOPMENT

# SITE: Lot 105 Penna Road, Penna

# PROPOSED DEVELOPMENT: DWELLING & OUTBUILDING

# **Bushfire Hazard Report**

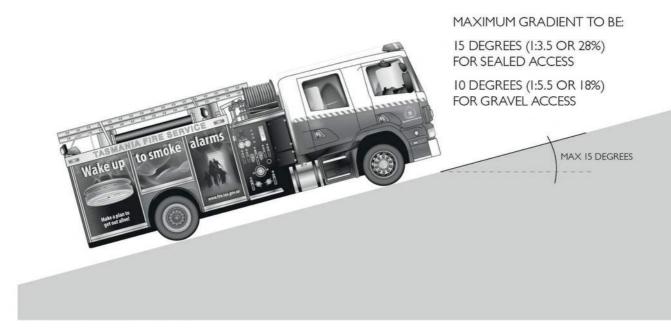
Figure 2 Gradient angles

## GRADIENT

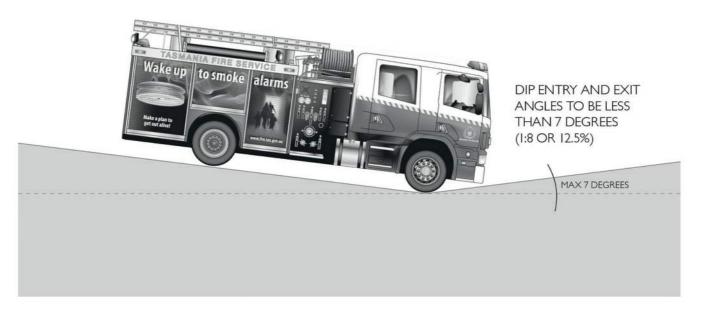
## Figure 3 Dip approach and exit angles

# DIPS
