NOTICE OF PROPOSED DEVELOPMENT

SITE: 513 Shark Point Road, Penna

DWELLING & CHANGE OF USE (DWELLING TO SECONDARY RESIDENCE)

PLANNING REPORT

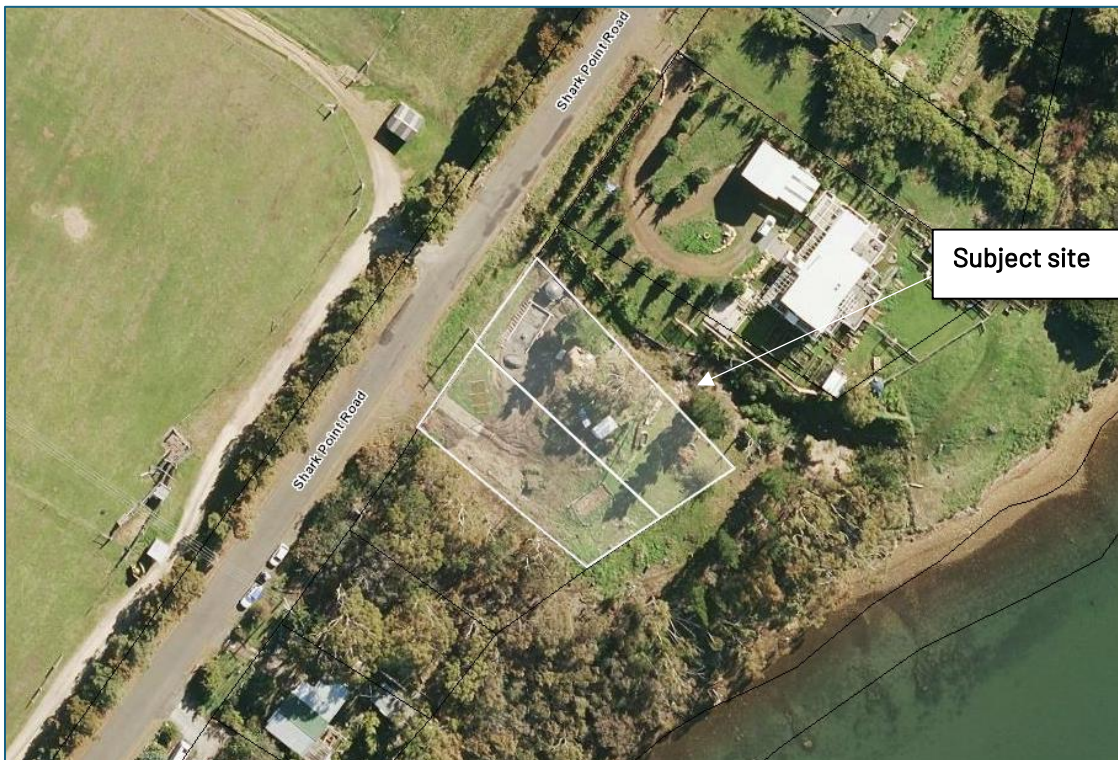
Figure 1 Aerial view of the subject site (Source: LIST)

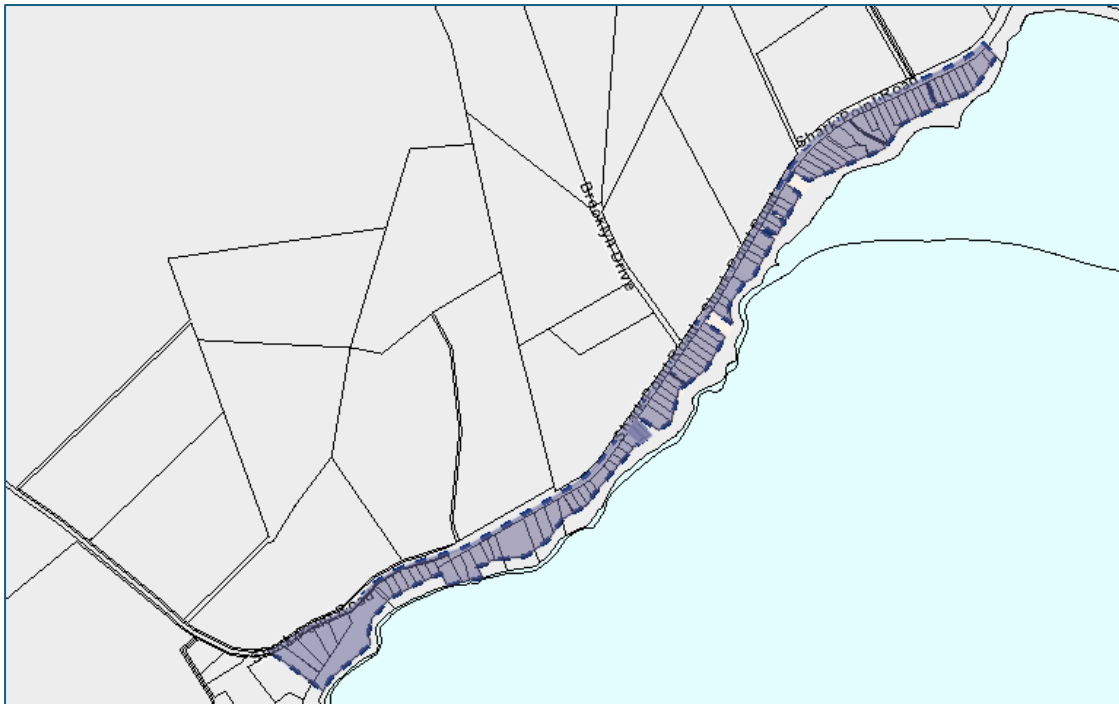
Figure 4 Area included in the SAP (Source: LIST)

The subject site is included in the Dispersive Soils Specific Area Plan (SAP)

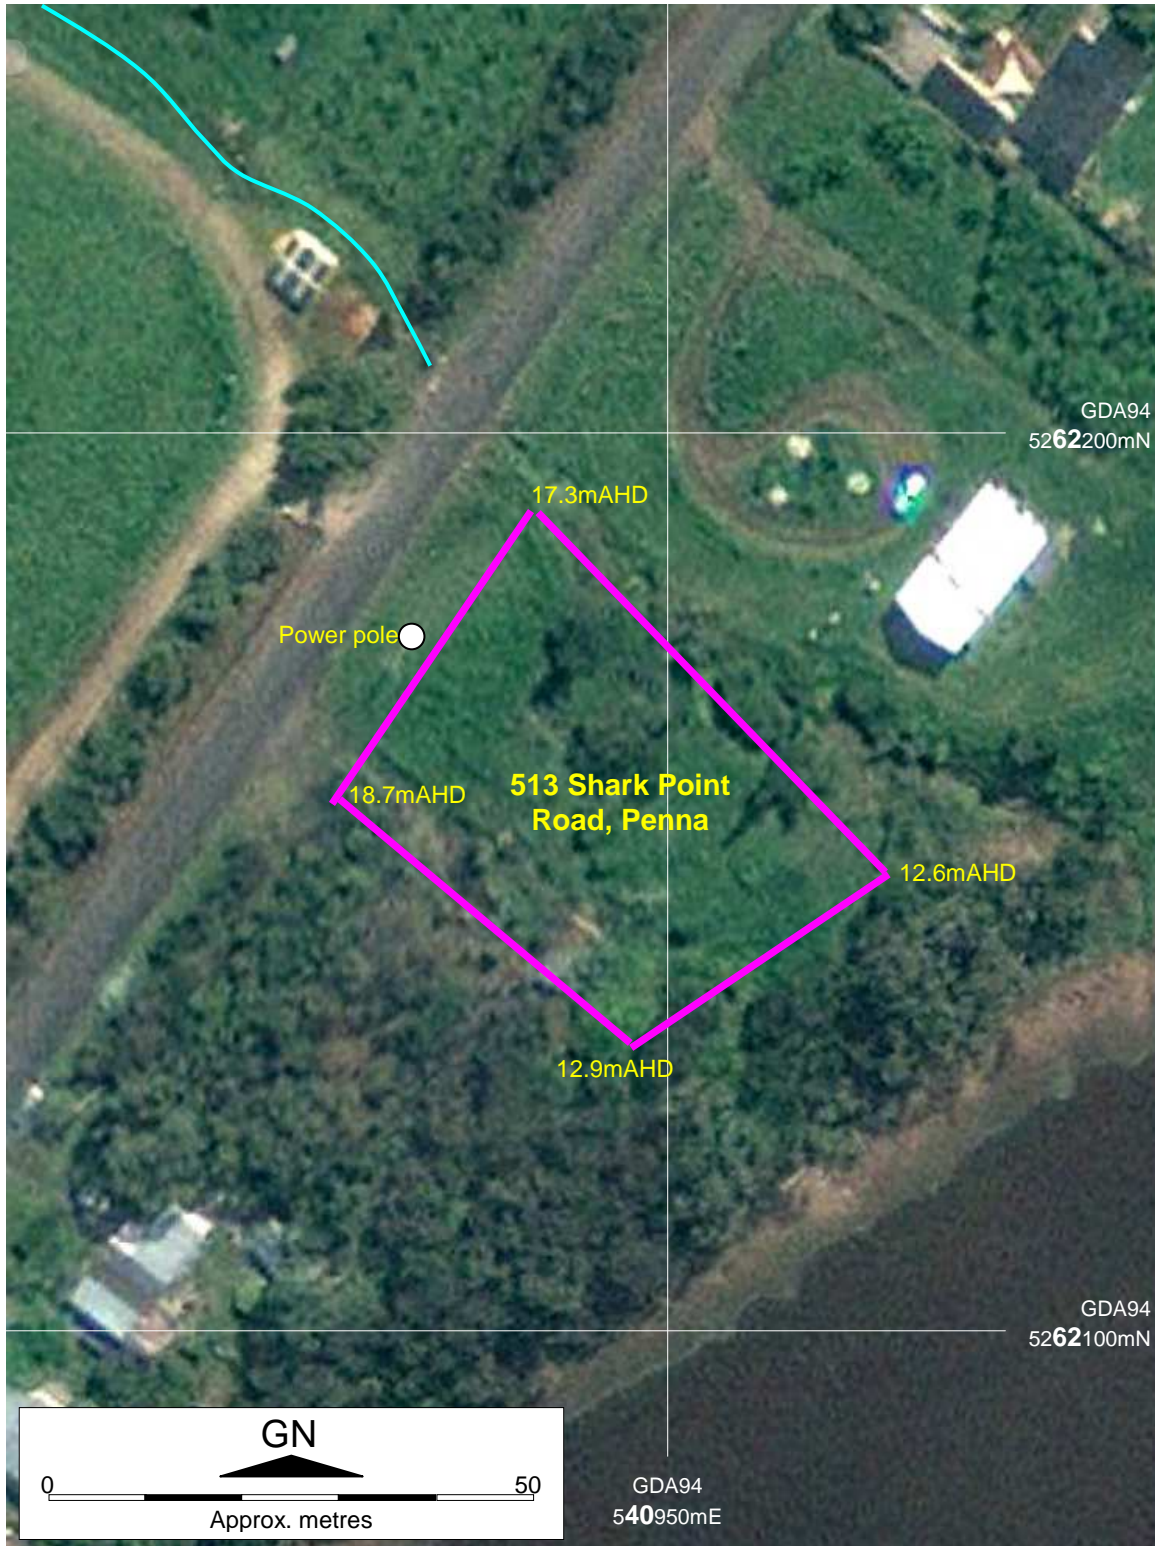
Attachment 2

Satellite imagery of the property

Property boundaries (in pink) are approximate. Do not scale.
(Sources: Google Earth; image date 2009, and Bob Ford Surveyors, Bellerive)

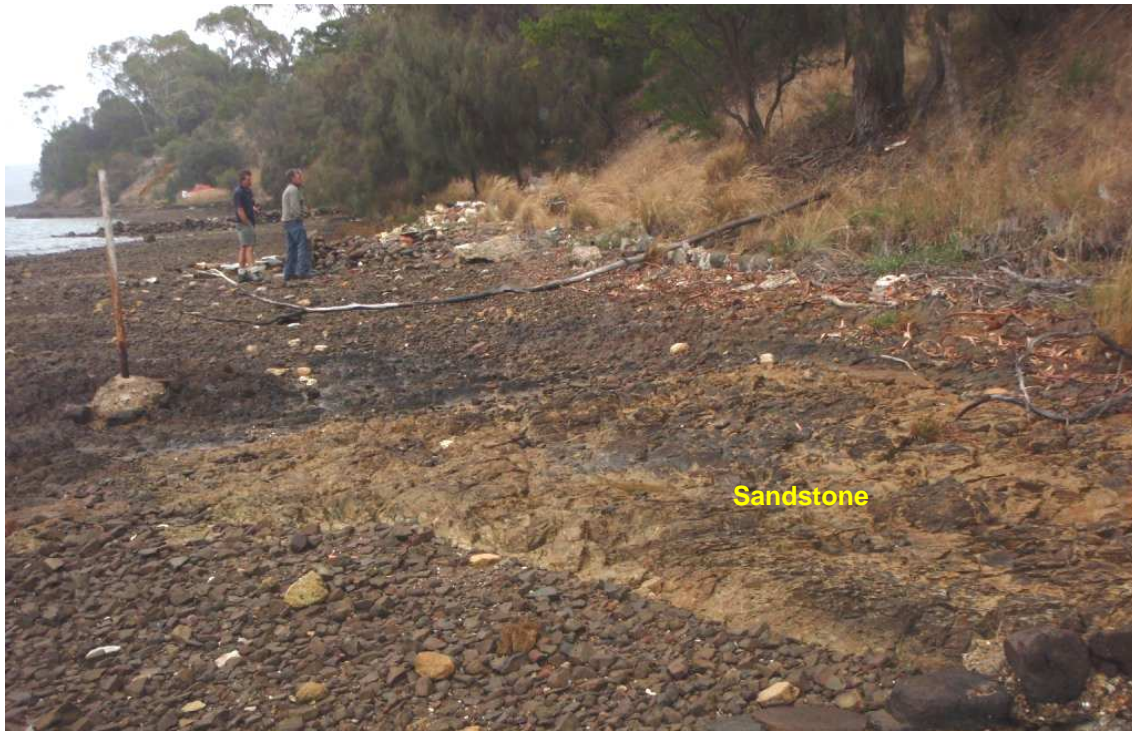
Plate 1 (above). View southwest on the foreshore below 513 Shark Point Road, showing baked, strongly fractured sandstone bedrock (right foreground) intruded by Jurassic dolerite.

Dolerite intruding Triassic or Permian sandstone and siltstone is well exposed on the foreshore below 513 Shark Point Road (Plates 1 and 2, Attachment 4), where it is moderately weathered and strongly fractured.

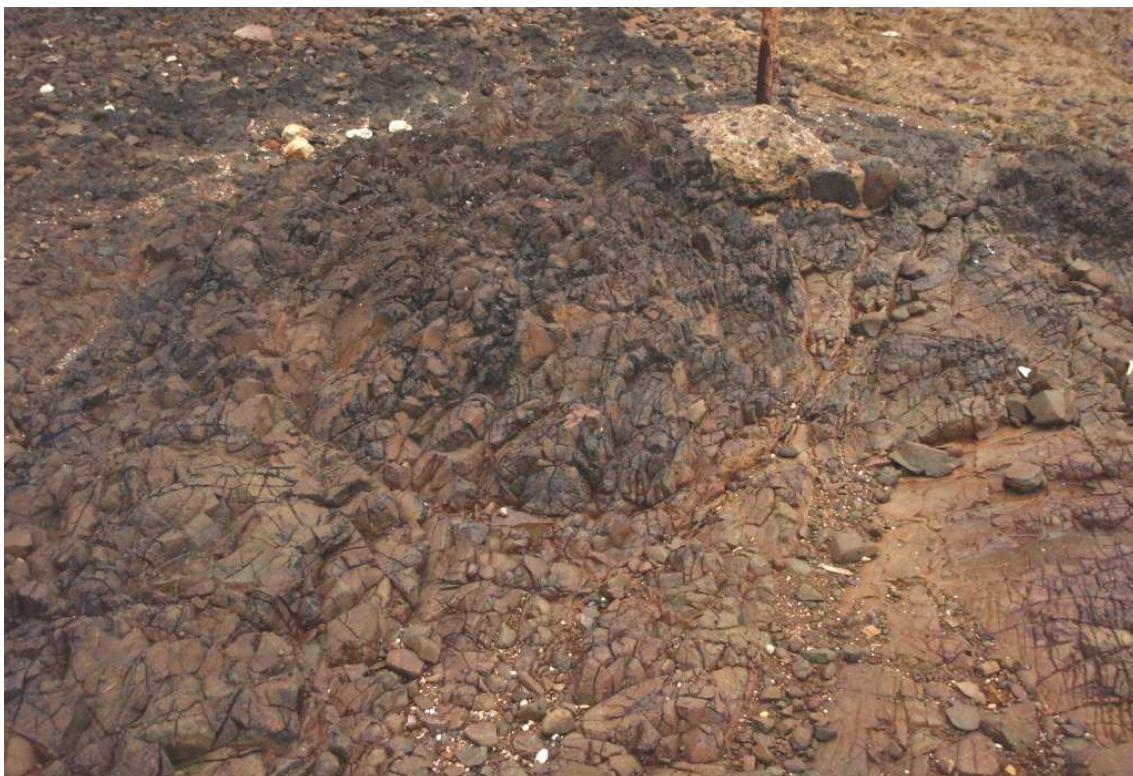
Plate 2 (below). Fine grained, strongly fractured Jurassic dolerite bedrock exposed on the foreshore below 513 Shark Point Road.

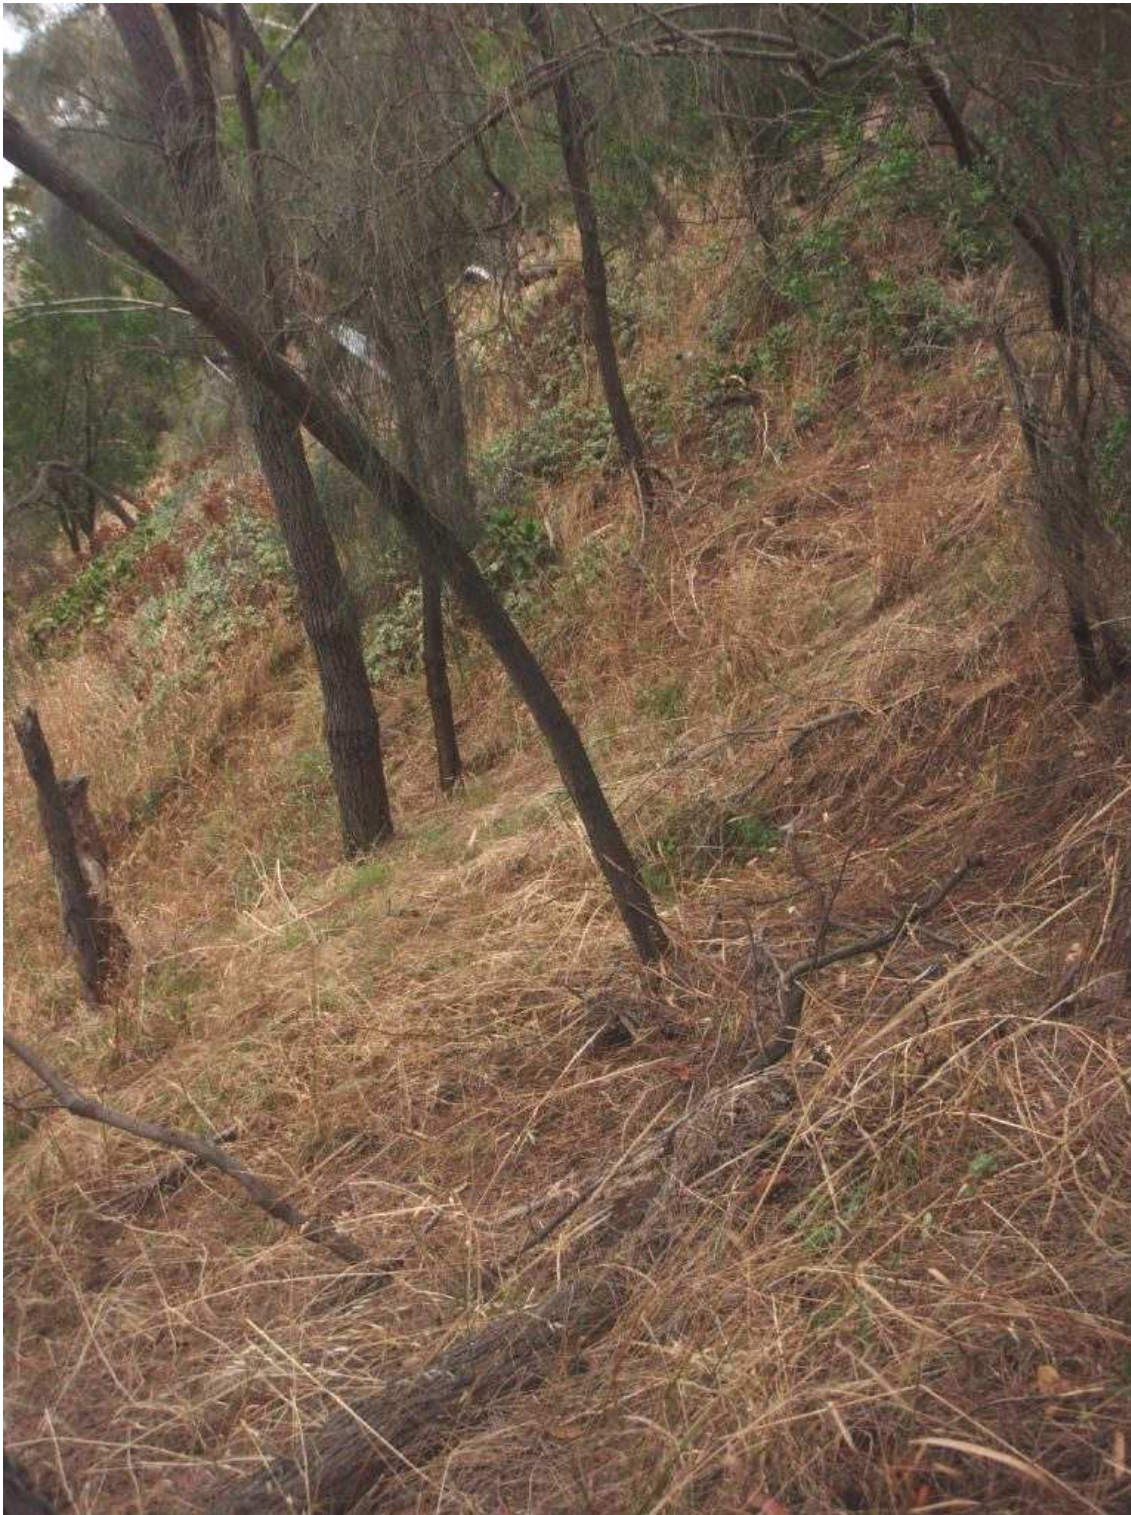
Plate 3 (above). View southwest across the 30 – 35° slopes of the embankment below 513 Shark Point Road. Hummocky ground and leaning and curved tree trunks indicate shallow-seated slope instability (mainly soil creep and small scale landsliding)

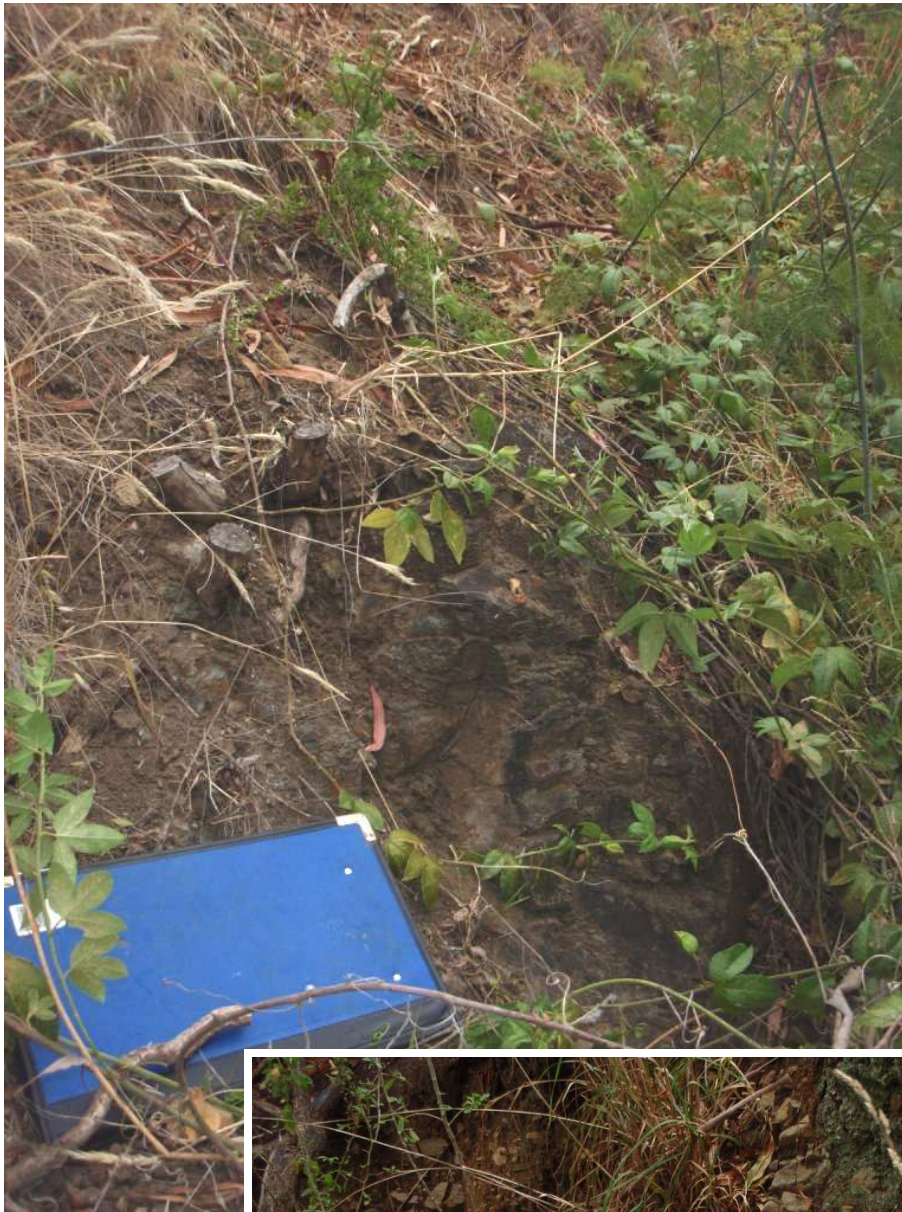
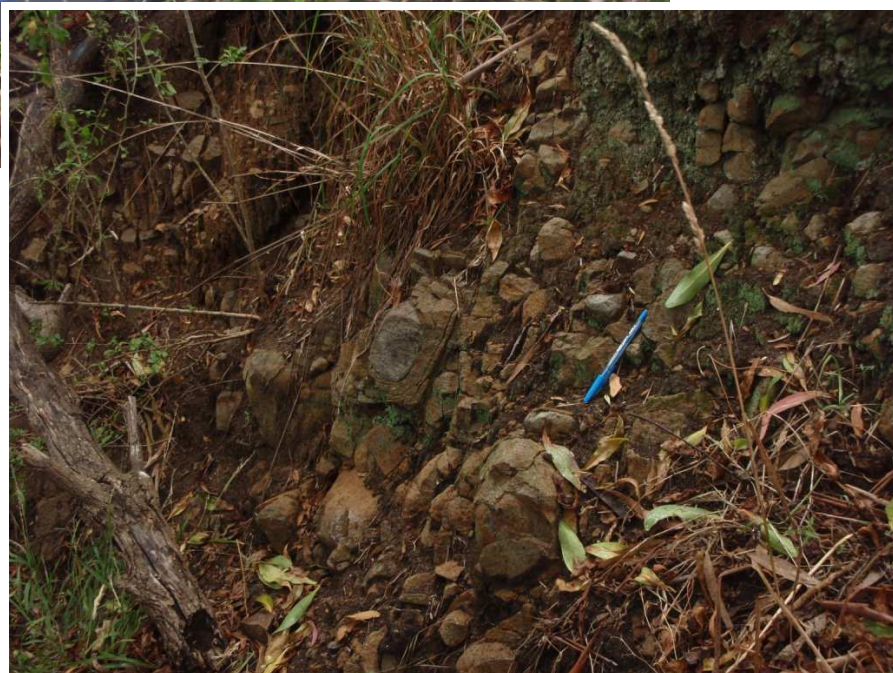
Plates 4 (left) and 5 (below). In-situ, strongly fractured Jurassic dolerite bedrock exposed in the banks of the intermittent creek along the northeastern boundary to 513 Shark Point Road.

Dolerite bedrock is also exposed on the banks of the intermittent creek along the property's northeastern boundary (Attachment 3; Plates 4 and 5, Attachment 4), and was observed in three of the four test pits dug for the present investigations (Attachment 3, and Table 5.1 this Attachment).

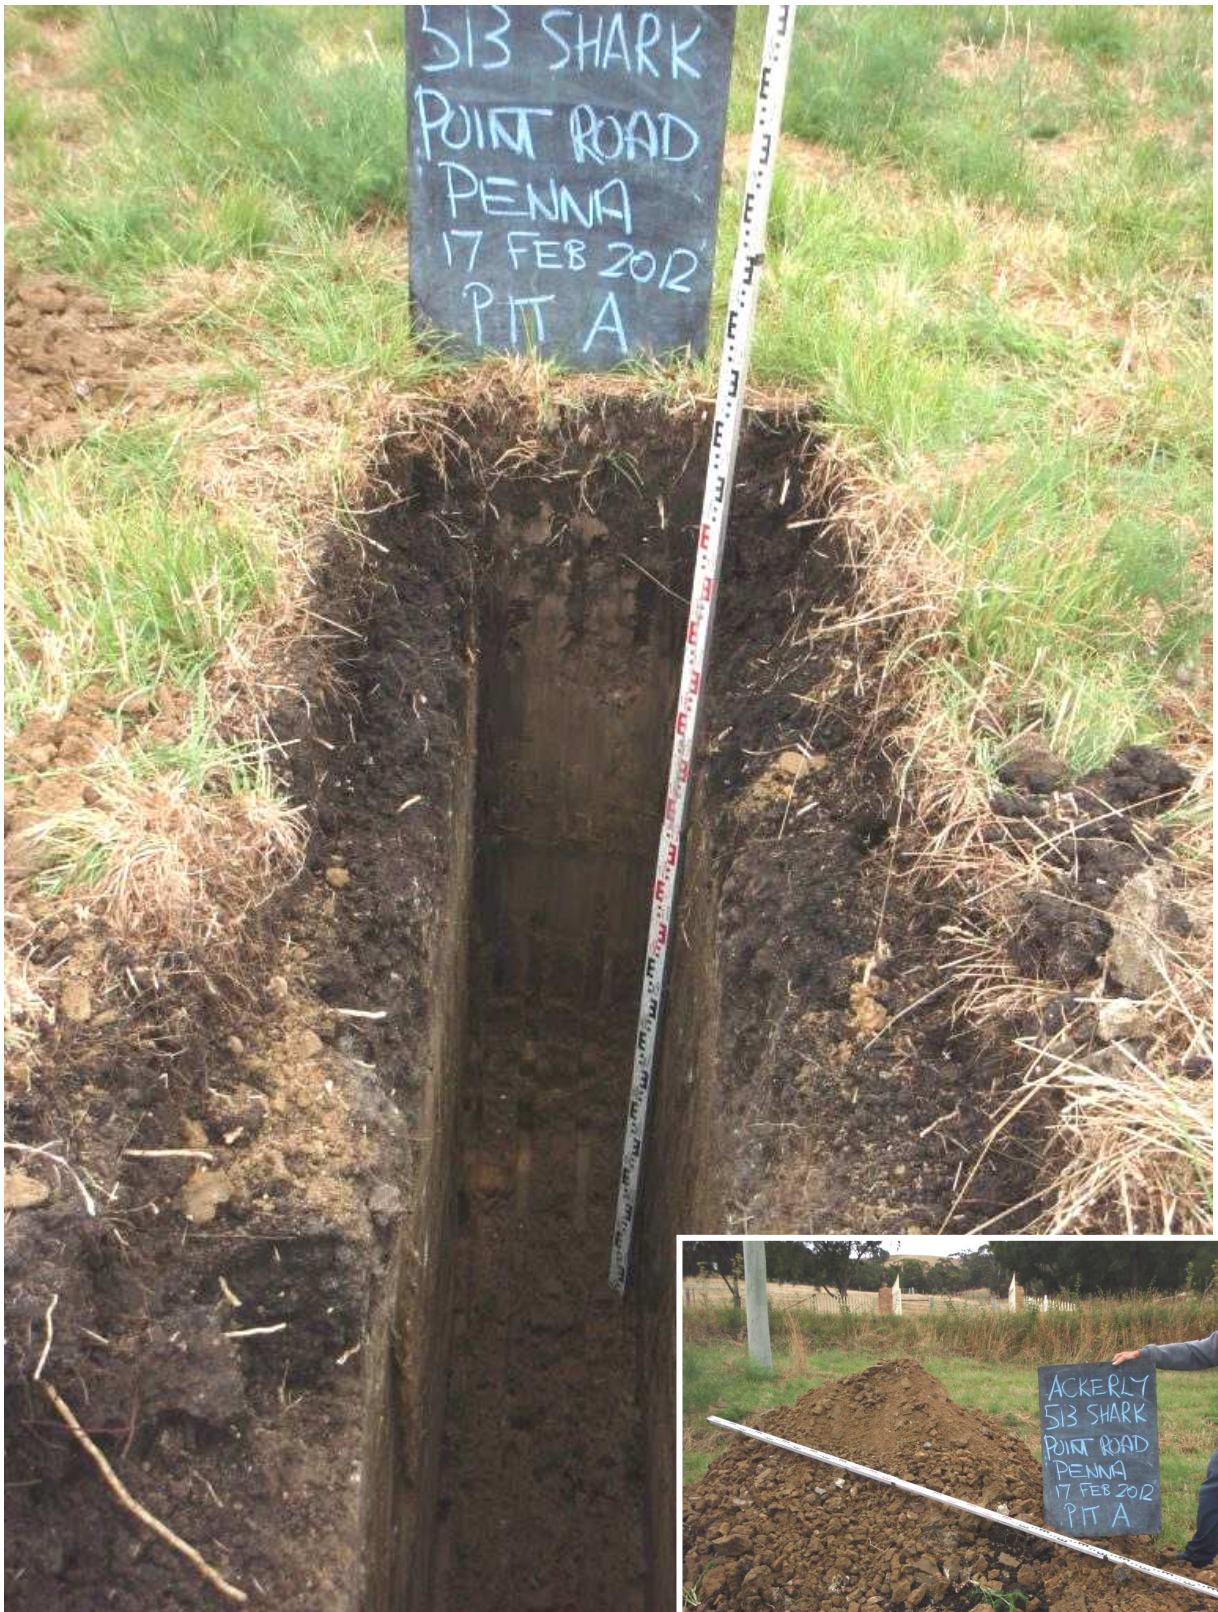
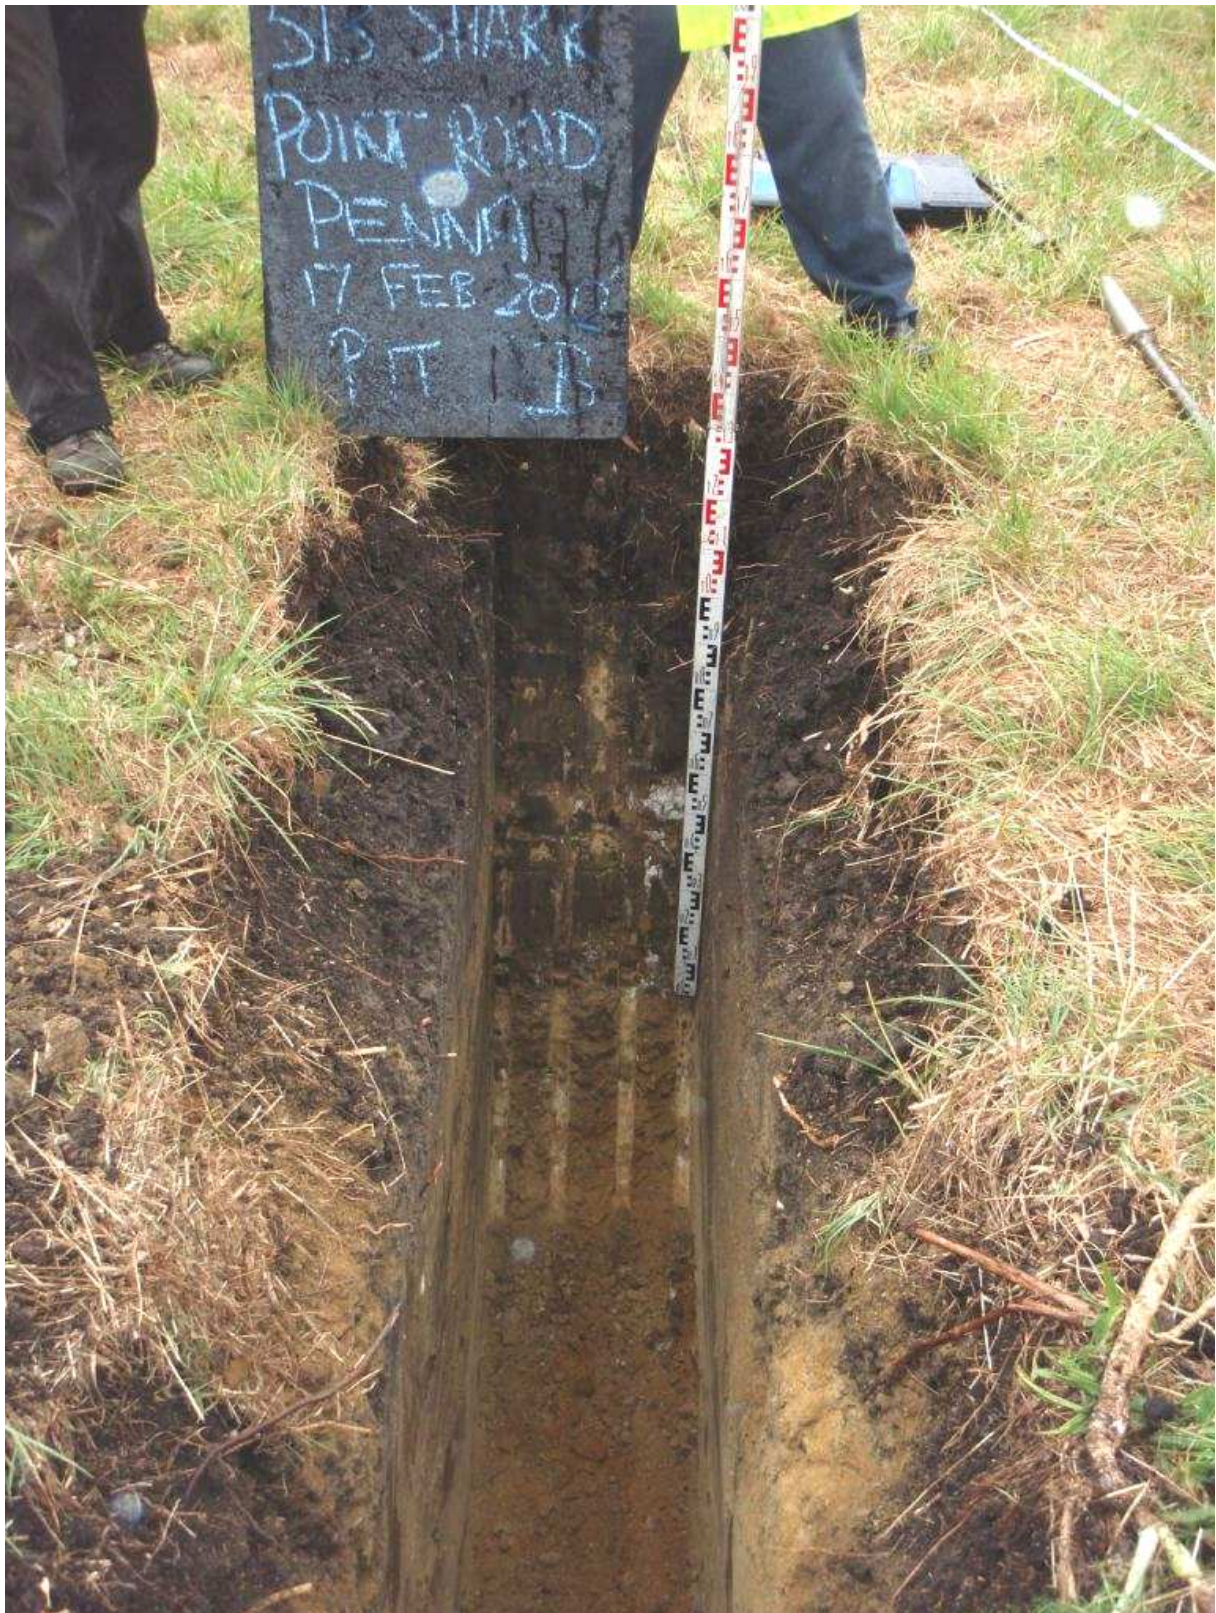
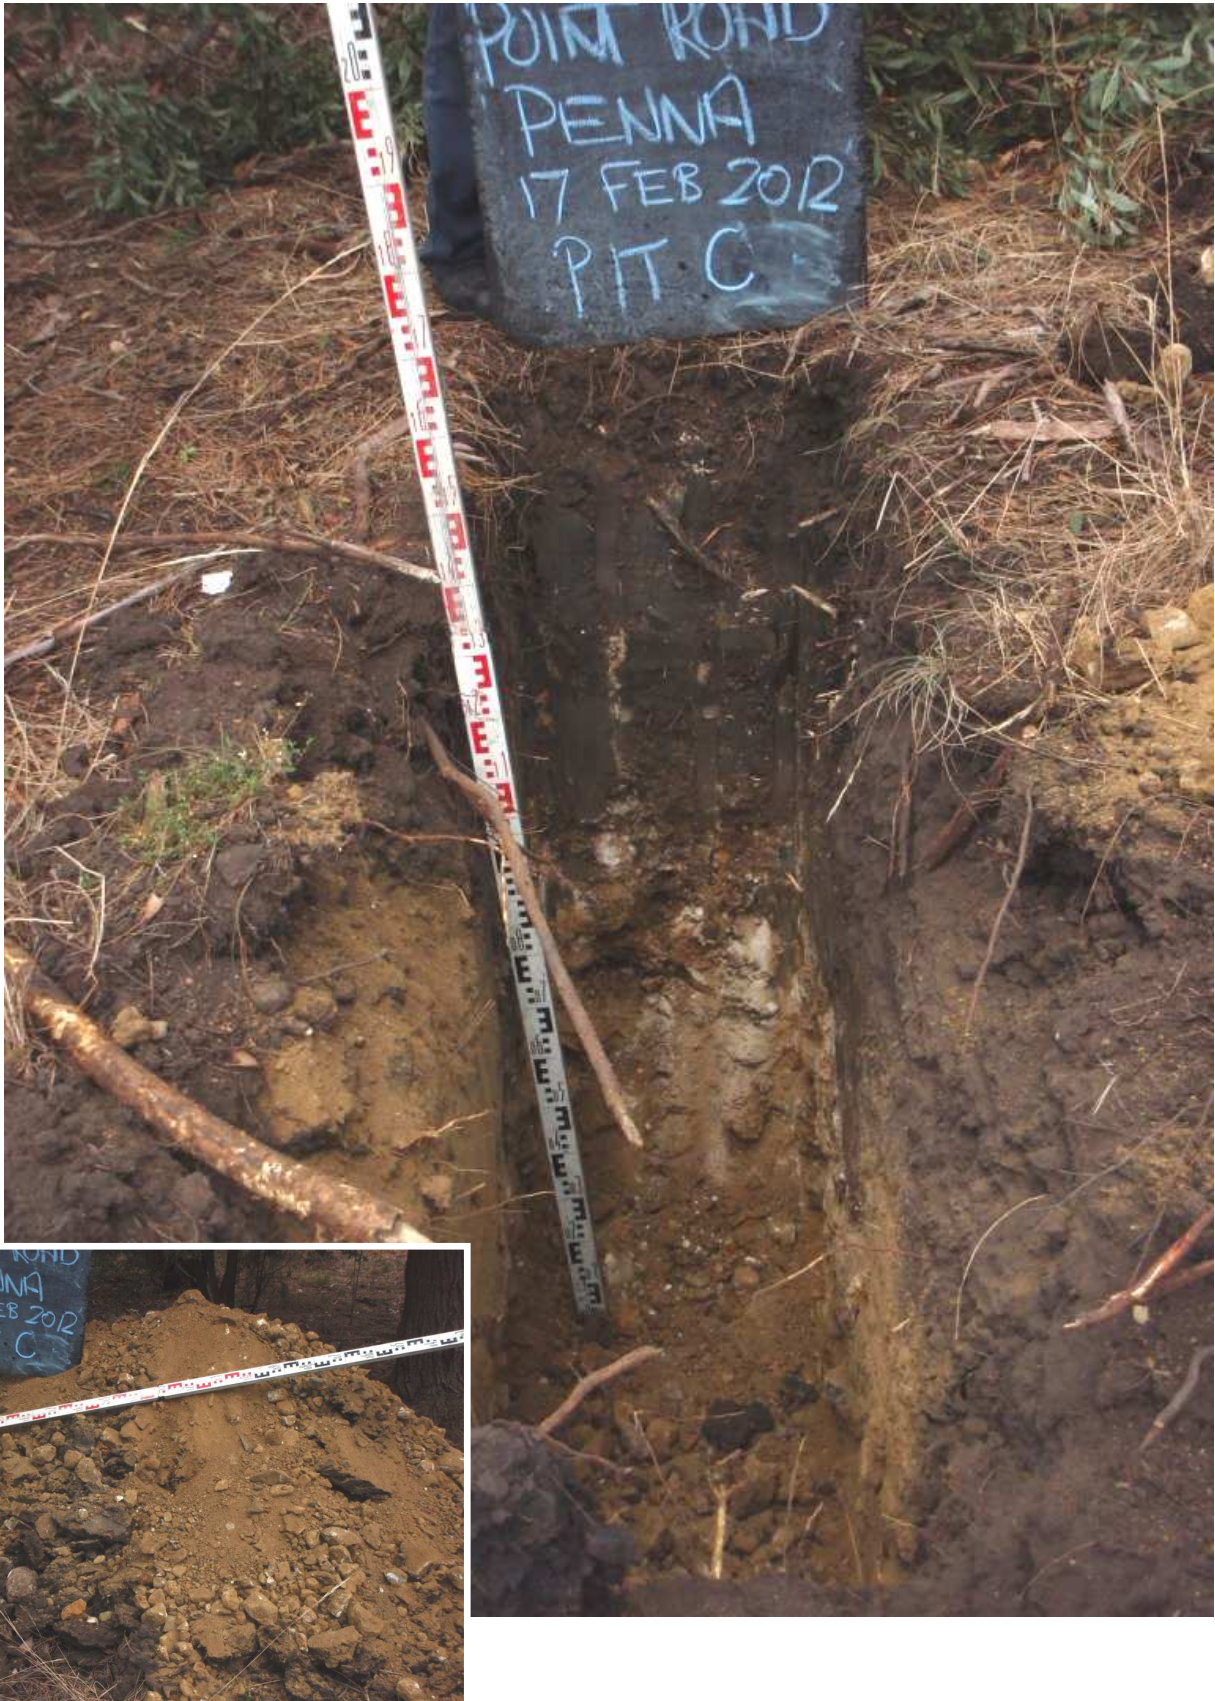
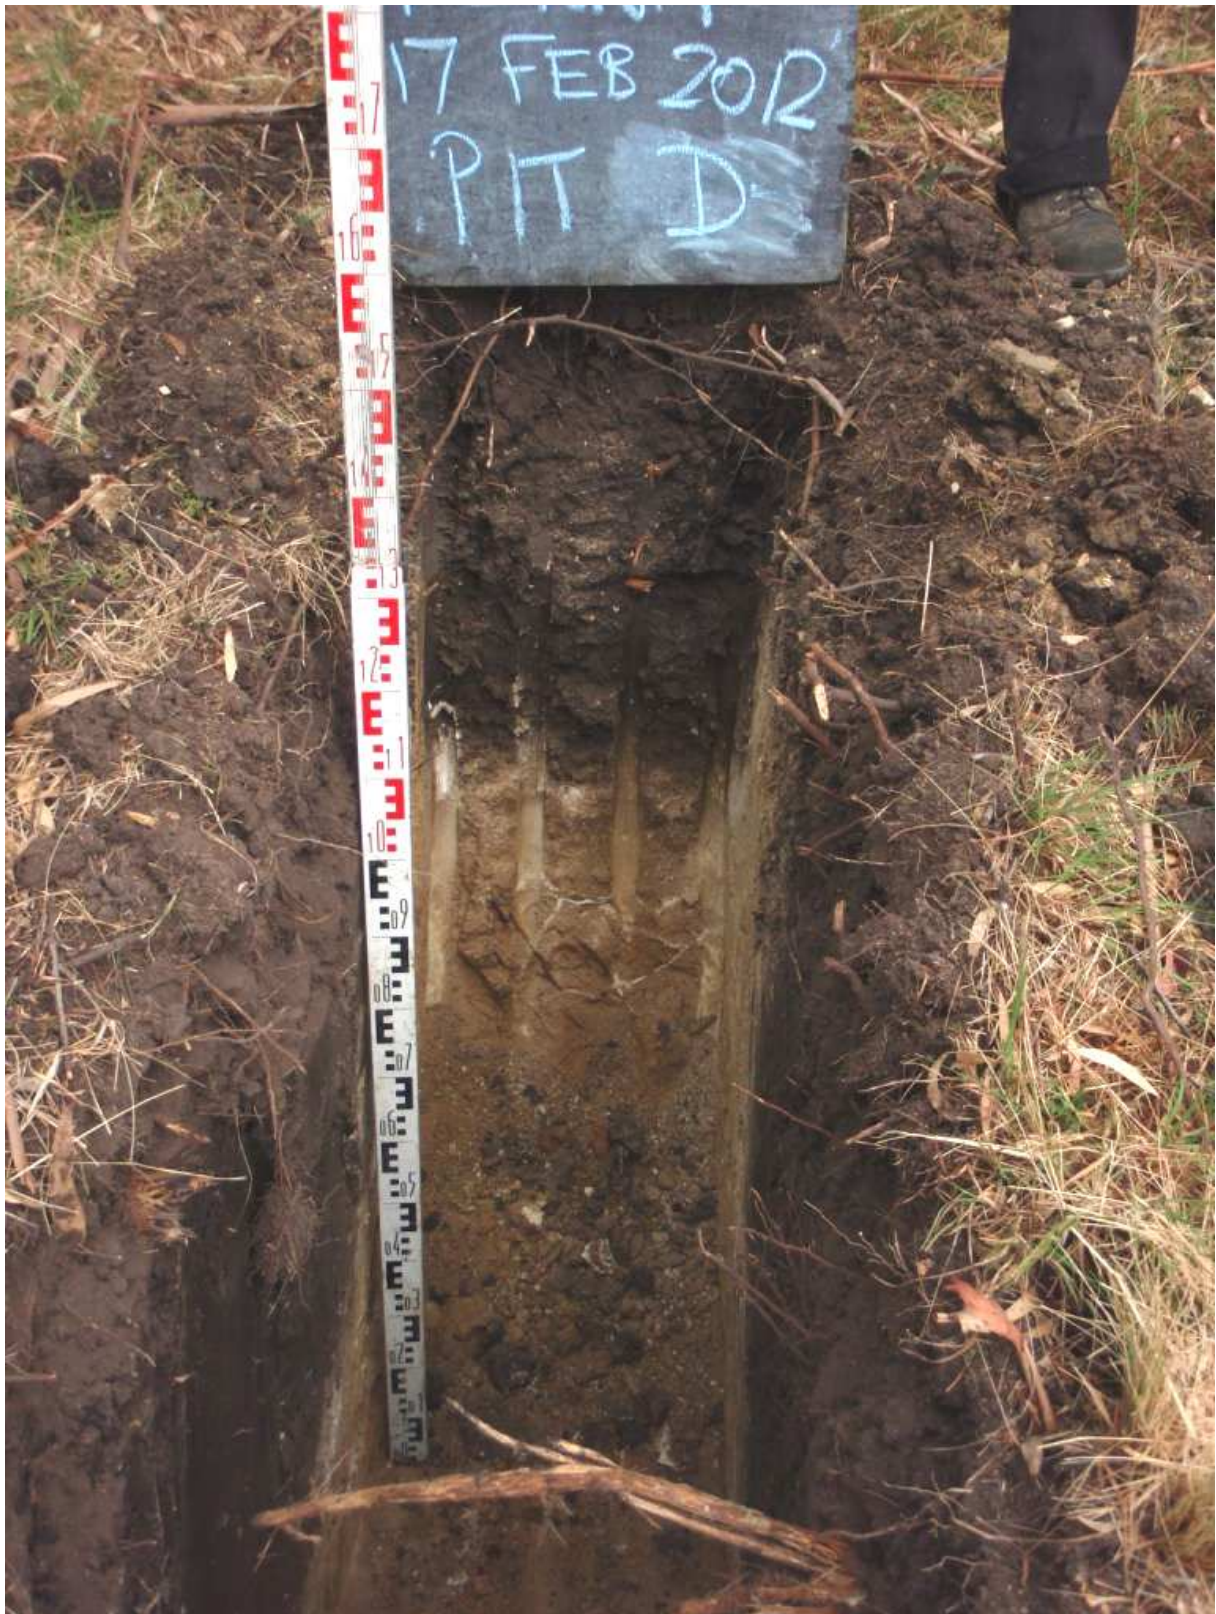
In the following photos of test pit profiles, the staff is graduated in metre long red and black segments. The symbol "E" and its reverse are 5cm high and the numbers are decimetres (tenths of a metre).
